Original research article

# Ecological Restoration of Degraded Concrete Waste Zones at the Nachtigal Dam Construction Site (Cameroon): A Methodological Approach for Plant Regeneration Dynamics

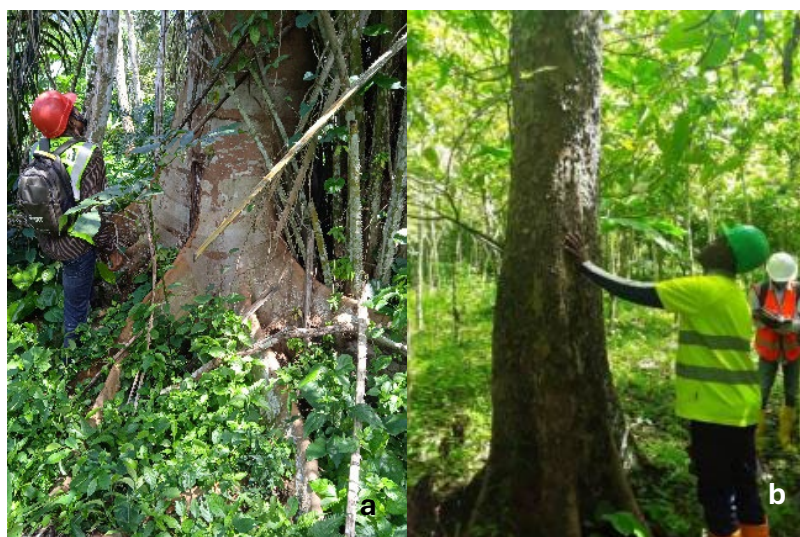
**Figure 2:** Plant inventory carried out in the Ndji forest: (a) Tree identification; (b) Tree height estimation

Thirdly, various lists were also established based on the botanical field inventories conducted in the forest ecosystems surrounding the project site, i.e., in Ndji forest, Ekombite-Ndoko forest and the forest around the dam area (Figure 2).

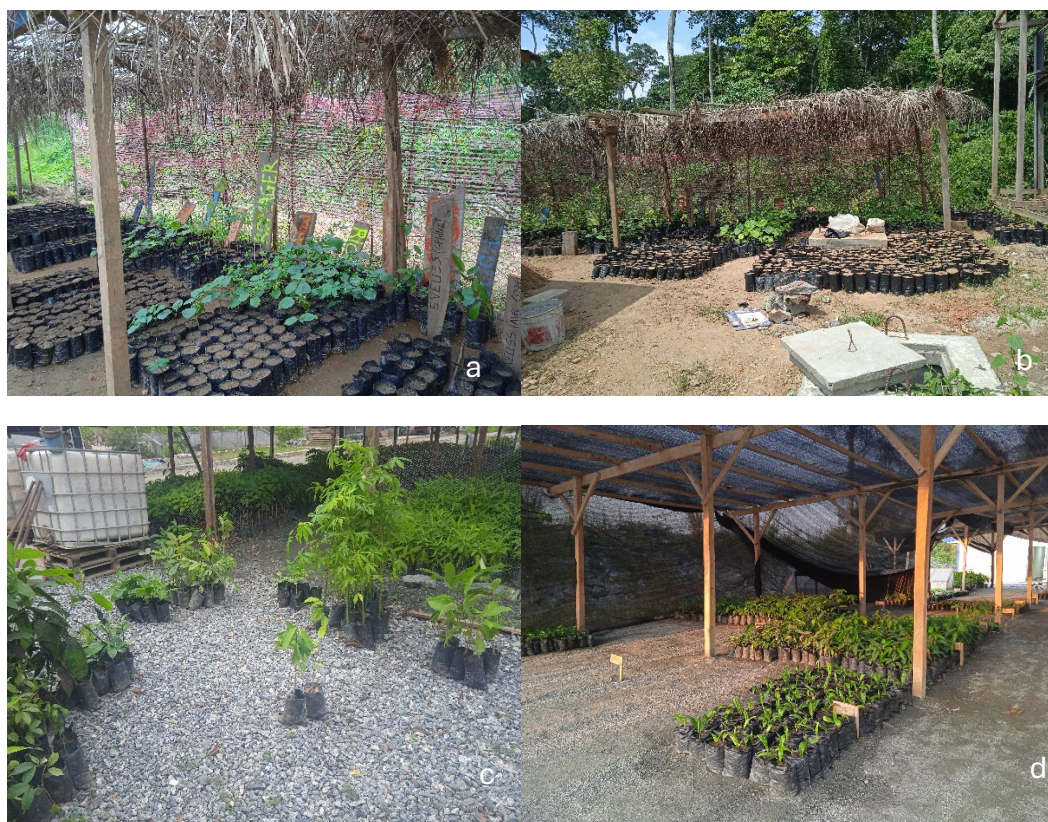
**Figure 3:** Nurseries used to accommodate various growing species from seeds and wild seedlings. (a) and (b) Nursery for seeds and stem cuttings; (c) and (d) nursery for fully germinated seeds and seedlings

During the field botanical campaigns, not only were seed-producing trees localised with a GPS for an eventual collection of seeds in fruiting season, but also the assessment of parameters such as inter-tree distances, observation of natural regeneration patterns in addition to dendrometric measurements (plant height and diameter), assessing species distribution and regeneration potential across sites. Seeds and wild seedlings were also collected at the foot of some seed-producing trees and planted in pods to boost plant production at the nursery established in one of the zones at the dam site. Actually, two nurseries were built (Figure 3) to accommodate the plants required for the reforestation of the site. The first nursery was used for early insemination, wild seedling planting, treatment and assistance (watering, fertilisation, bio pesticide application when necessary, etc.), modified from Ngono *et al.* (2021); the other, of 300 m<sup>2</sup> was where the young plants were kept to grow under an established 60% shade net and monitored before being transferred to the plantation sites.

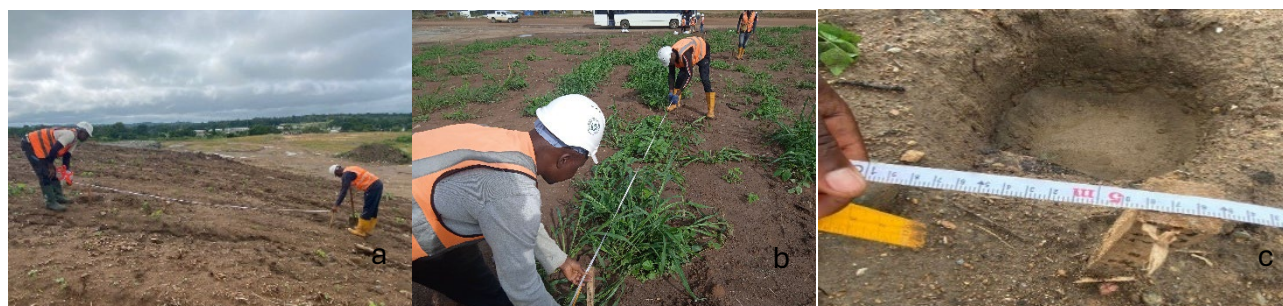
**Figure 5:** Planting disposition. (a) and (b) Measuring the spacing between future plants; (c) Dimension of the hole reserved for planting

After soil remodelling, the areas were subjected to planting. Zones A and B were planted in November 2023 and April - May 2024, respectively. Four hundred and fifty (450) different plants selected as described above and grown in nurseries were introduced randomly in each hectare of land based on a modified standard procedure (Figure 5) by Ngono *et al.* (2021). Thus, for zone A, 348 plants were installed in an area of 8924.72 m<sup>2</sup>, while in zone B of 15733 m<sup>2</sup>, approx. 1.6 ha, 698 plants (278 and 420) were planted in two phases. The seedlings were spaced at 20 m<sup>2</sup> from each other in planting holes of 30 x 30 x 30 cm<sup>3</sup> manually excavated and half-filled with topsoil enriched with a mixture of compost + sawdust + chicken droppings in the 1:1:1 ratio. Species were placed randomly in an interwoven pattern, ensuring a 40 : 60 ratio, respectively, for NTFP-producing plants and timber species per hectare.

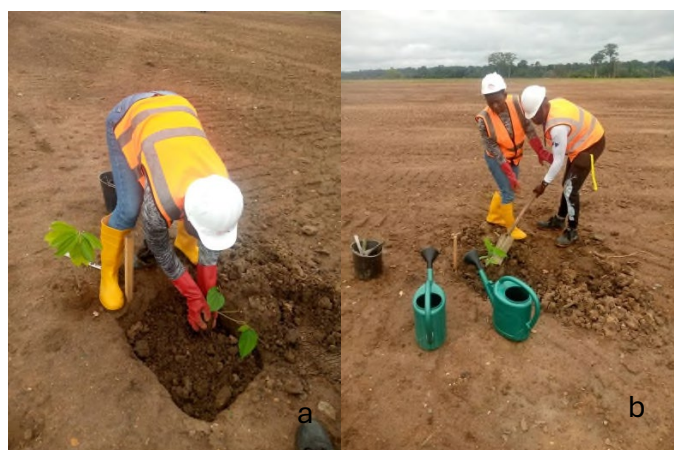
**Figure 6:** Planting process. (a) Planting of seedlings and (b) Early watering.

After planting, the young plants were watered twice a week, especially during the dry season (Figure 6). In the rainy season, soil erosion control mechanisms (addition of more soil and replanting) were implemented.

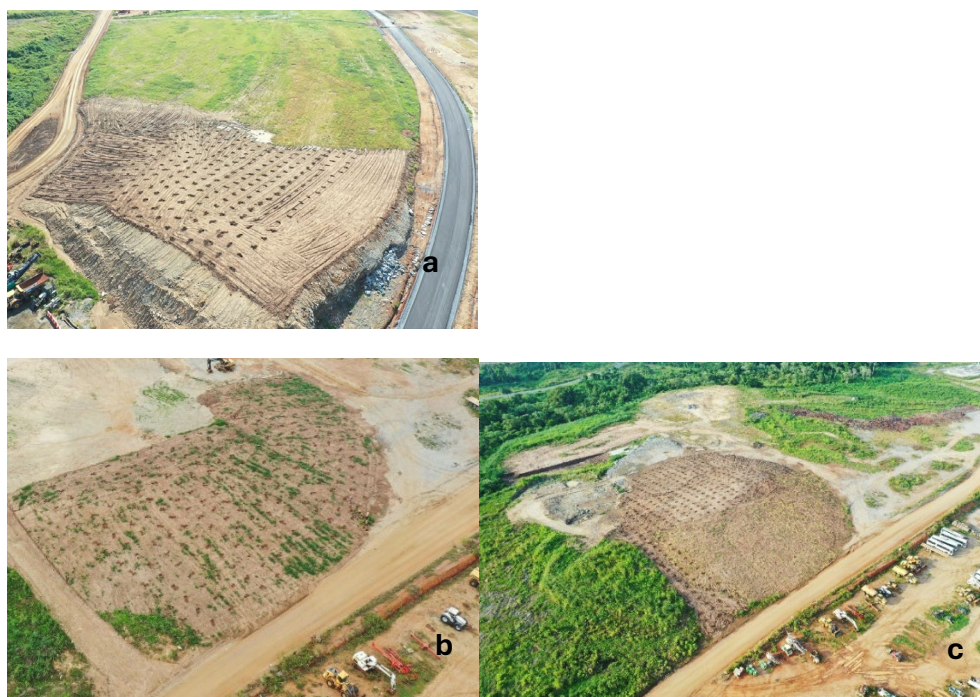
**Figure 8:** Display of holes on the various surface areas. (a) Zone A; (b) and (c) Zone B.

The planting layout in both restoration sites (Zones A and B) is illustrated in Figure 8.

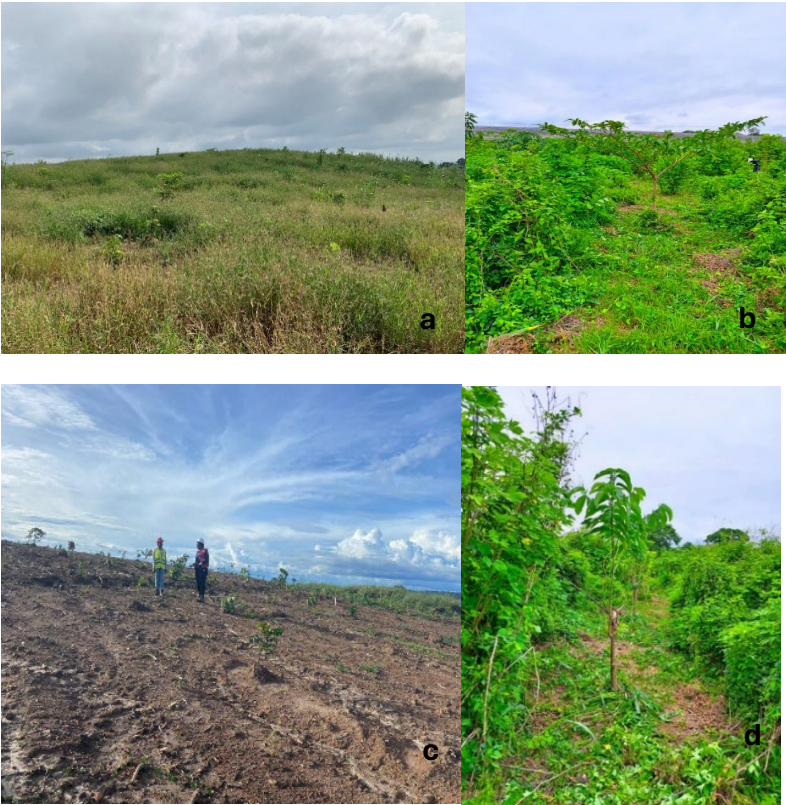
Figure 10: Growing vegetation cover (a) at six months; (b) after 12 months in zone A; (c) at two months and d) after 12 months in zone B

With regards to vegetation cover and site physiognomy, at the time of completion of this study, both zones displayed a dense, evolutive plant community with some dominant species such as *Ricinodendron heudelotii* (Baill.) Pierre ex Heckel, *Ceiba pentandra* (L.) Gaertn. and *Triplochiton scleroxylon* K. Shum forming an early-phase forest structure. Figure 10 demonstrates the re-establishment of vegetative cover on the study areas.

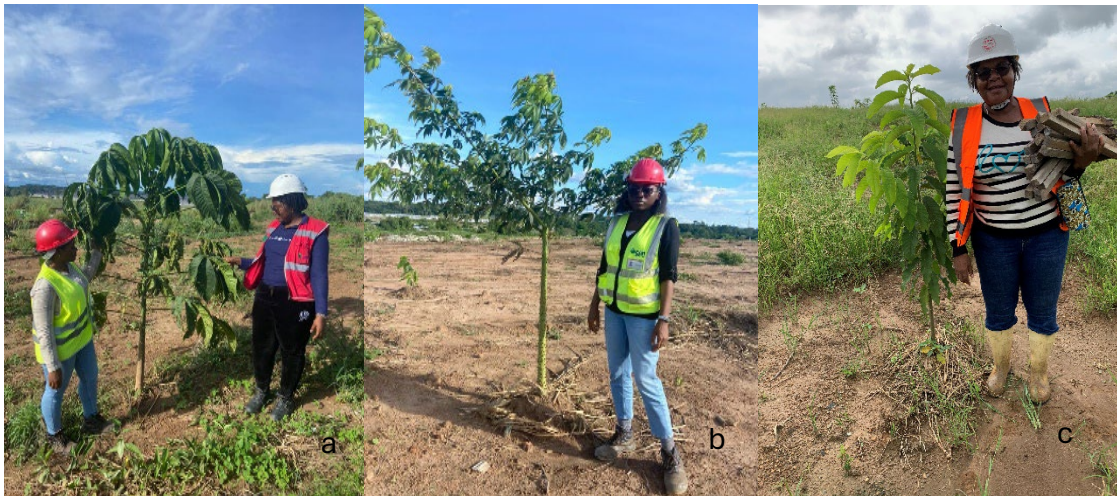
**Figure 11:** Plant heights measured approximately based on human heights: (a) *R. heudelotii*, (b) *C. pentandra*, and (c) *T. scleroxylon*, respectively.

Within 12 months of monitoring, several species were found between 1.5-2.0m high. Figure 11 illustrates the height of some dominant plants (*Ricinodendron heudelotii*, *Ceiba pentandra* and *Triplochiton scleroxylon*, respectively) based on human references selected between 1.63 and 1.75 m tall.

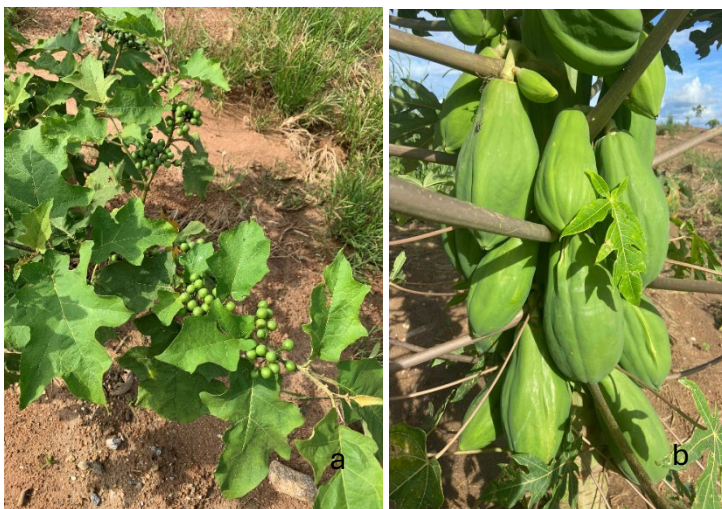
**Figure 12:** Ongoing fructification of some species (a.) *Solanum torvum* and (b.) *Carica papaya*

Certain species such as *Solanum torvum* Sw. and *Carica papaya* L. were already at their fructification stage (Figure 12), thus illustrating the capacity of the rehabilitated zone to offer the ecosystemic services aimed for.

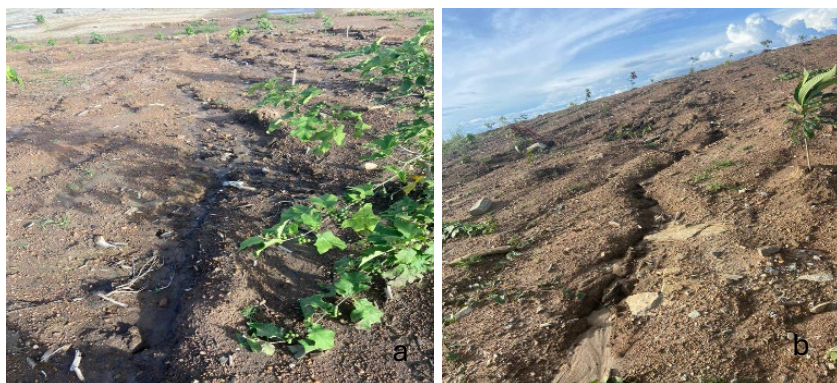
**Figure 13:** Visible erosion effect on restored sites: (a) in zone A and (b) in zone B

Some hindering factors, such as soil erosion during the rainy season (Figure 13), high temperatures on bare soil, and the strong wind blowing on the sloppy landscape, were observed to inhibit normal growth of some plant individuals and hence became enabling factors for increased plant mortality rates. This phenomenon was more accentuated in zone B with steeper slopes. Additional measures such as the use of more topsoil to reshape and refill eroded areas and replacing lost plants were carried out.
